EASTERN STATE PENITENTIARY

Visitor Center Phase One Construction Updates

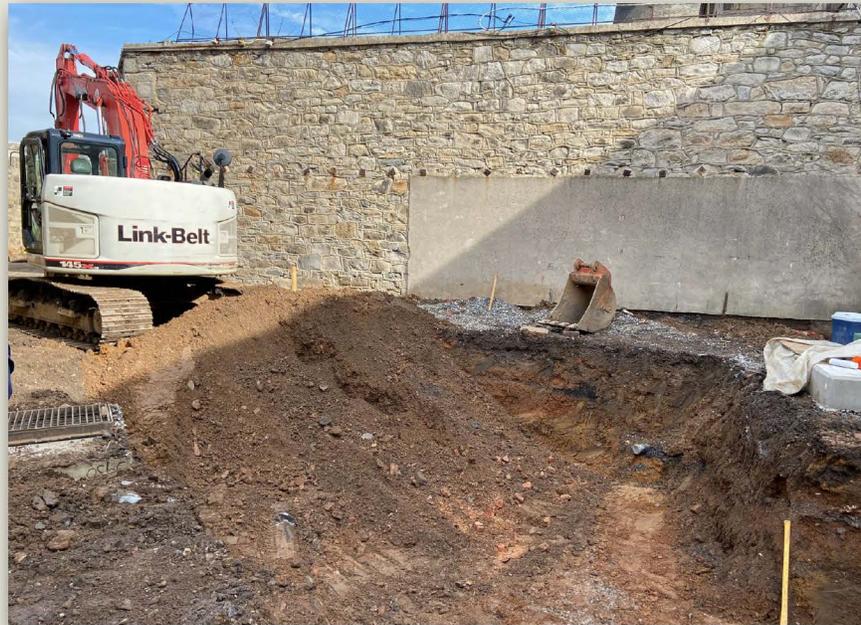
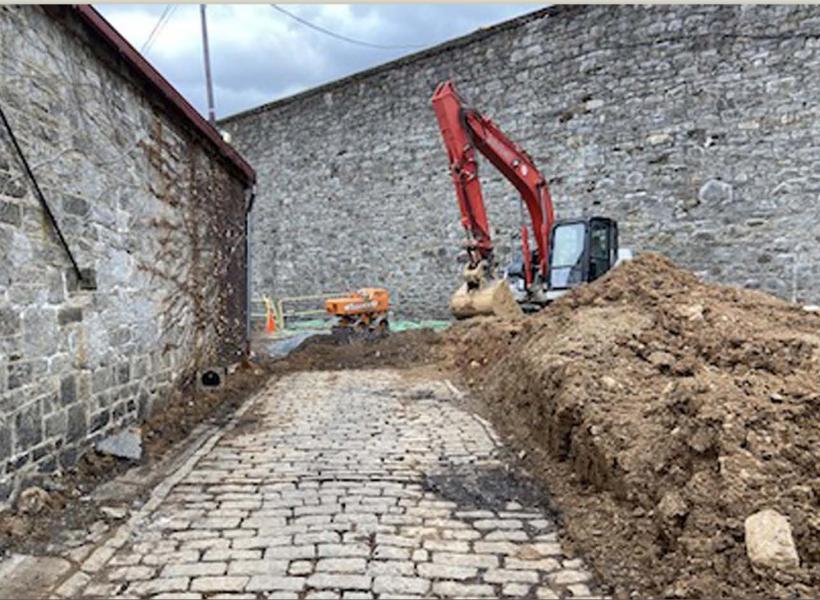
Our team of contractors demolished the stairs leading out of the admissions area. They also prepared the site for underground infrastructure updates by demolishing existing paving and excavating underlying soil.

Meanwhile, we took this rare opportunity to study newly uncovered parts of the building and documented the foundations of the south perimeter wall.

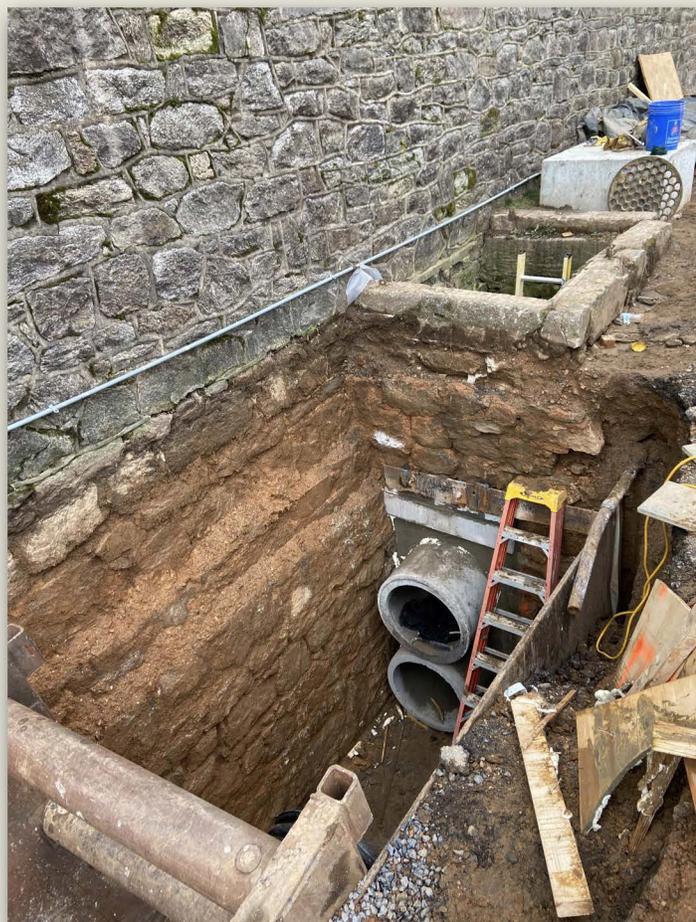
Excavation in the front of the penitentiary continues as contractors lay conduit to provide electricity for our future visitor center. We also furthered our study of Eastern State's perimeter wall.

We learned that the foundation of the wall is much deeper in some places than we originally thought. Challenging our long-held belief that the wall extended ten feet below ground, contractors dug over 20 feet down in one spot and still had not reached the bottom.

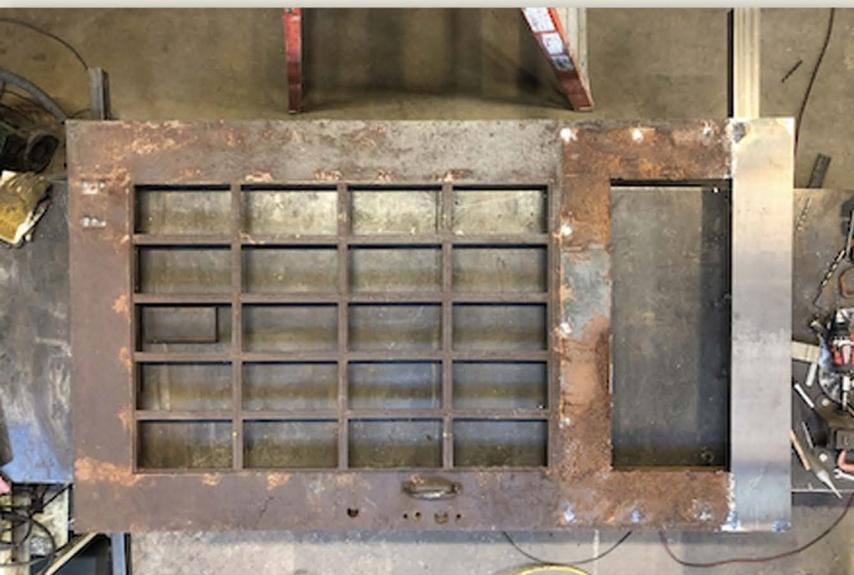
The Bertillon, which used to serve as Eastern State's prisoner intake area, is getting some upgrades. In addition to rebuilding the stairs, replacing the planter beds, and constructing a new ramp for ADA accessibility, the two steel entry doors to the Bertillon are being restored.

Conservators from Materials Conservation brought the 400-pound doors to their workshop, removed the rusted portions, and are now working too carefully integrate new steel and restore the doors to their original profile.

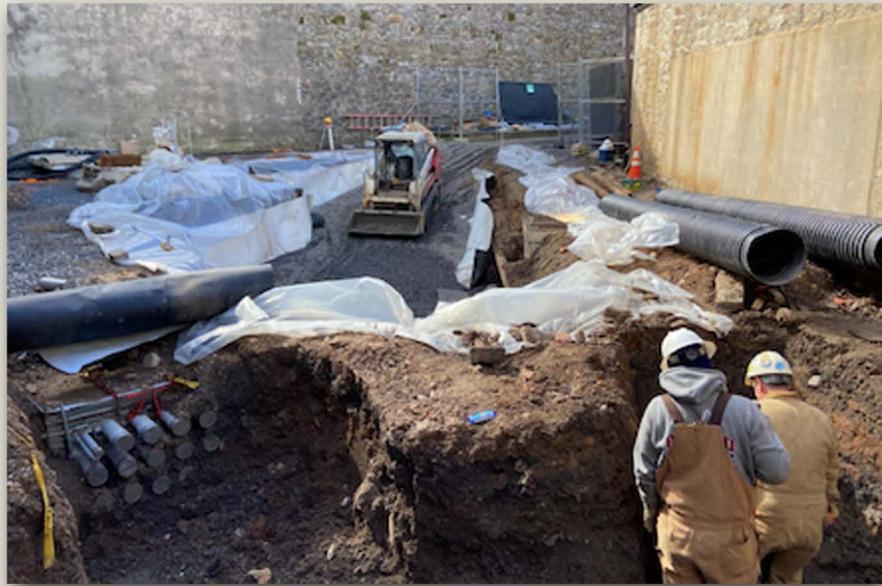
With the help of several generous grants, we laid the groundwork for future amenities at Eastern State and, at the same time, invested in making our neighborhood a little bit greener. Contractors built new "subsurface infiltration basins" to integrate green stormwater practices into our site infrastructure.

The basins, buried feet below concrete paving, will collect and store stormwater in perforated pipes and a bed of gravel before allowing the water to slowly seep into the ground. This system will reduce flooding, naturally filter pollutants from the water, and increase groundwater to help local streams and creeks in times of drought.
